**STRUCTURAL REINFORCEMENT TECHNIQUES IN HERITAGE BUILDINGS
FOR ADOBE MASONRY FOR A CORRECT INTERVENTION
TÉCNICAS DE REFORZAMIENTO ESTRUCTURAL EN EDIFICACIONES
PATRIMONIALES PARA MAMPOSTERÍAS DE ADOBE PARA UNA CORRECTA
INTERVENCIÓN**

This research presents a structural reinforcement method suitable for heritage structures featuring adobe walls compromised by fissures. The intervention involves the employment of traditional materials and techniques including: lime, clay, wild grass, and nopal mucilage for mortars and grouting. The applied methodology follows a quantitative approach, focusing on an experimental design, and was implemented in this structural reinforcement to restore masonry affected by cracks caused by settlements, seismic movements, or material fatigue within the wall, leading to a reduction in its mechanical resistance properties, such as compressive, flexural, and tensile strength. This indicates the need to restore the original mechanical properties of the masonry. The structural reinforcement was carried out following these steps: damage assessment of the wall, including an investigation to determine the presence of any mural paintings on the plaster. As no valu

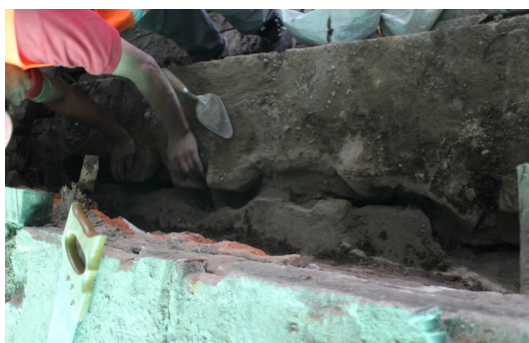
Figure 3

Image of longitudinal crack in the top of the Franciscan Third Order Chape

mentioned: longitudinal shear cracks that generally affect the heads of the walls (Fig. 3), flexural cracking that can affect the arches of a wall (Fig. 4), horizontal cracks, vertical cracks, diagonal cracks, inter-wall cracks, wall collapse and wall head fatigue (Achig et al., 2013).

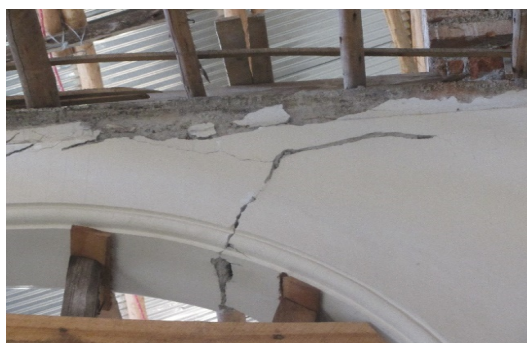
Figure 4

Image of fissure affecting wall arches (kidney) in the church of the Hospital Psiquiátrico Corazón de Jesús.

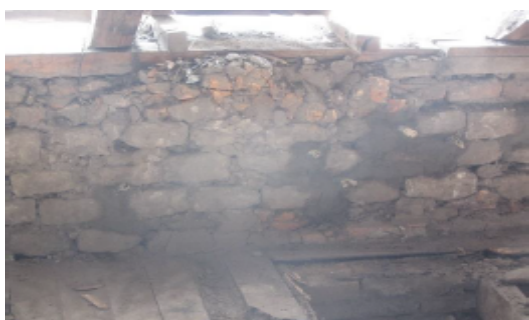
Figure 5

Image of the Casa de las Velas head fatigue

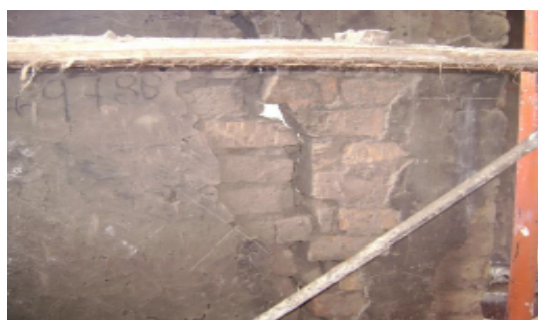
Figure 6

Image of vertical crack in wall Casa de las Velas.

On the other hand, among the main types of damage generally suffered by the heritage buildings of the Historic Center of the city of Quito, several types of degradation of the masonry can be established, which have been produced by different agents that trigger them, such as: atmospheric agents, deterioration of the adobe due to material fatigue (Fig.5) and by the seismic movements suffered, which contributed to the processes of structural failures that produce cracks in the masonry (Fig.6) of the heritage monuments.

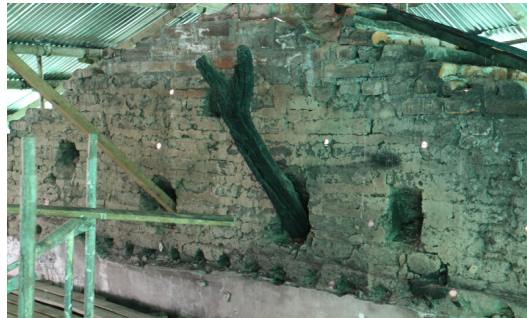
Figure 7

The materials used for the masonry, mainly in heritage buildings, are made of adobe and, in certain parts of the walls, are combined with brick or stone. It is also worth mentioning that the roofs and mezzanines are made of eucalyptus wood, as can be seen (Figure 7).

Image of the adobe wall Franciscan Third Order Chapel

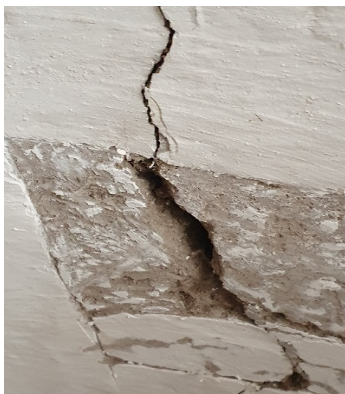
Figure 8

- First, the sectors where cracks were present were located.
- Then we proceeded to make coves⁷ of prospection on the existing paint (Figure 8).
- Verification of the existence or not of mural painting on the mud plaster (Figure 9).

Image of coves that are made on the painting, the presence of mural painting is not seen

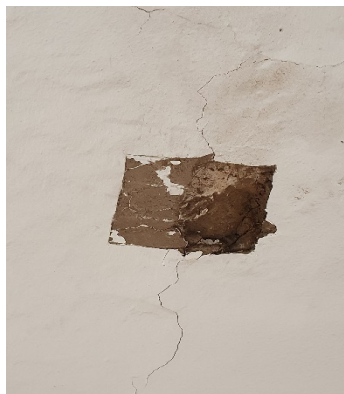
Figure 9

Image of mud plaster removal detecting the type of crack affecting the masonry

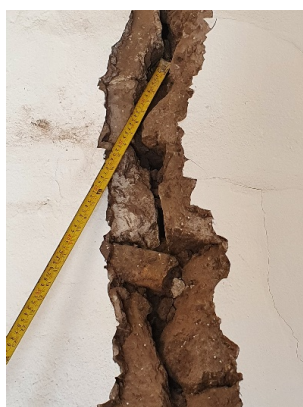
Figure 10

Once it was verified that there was no mural painting, coves were made on the plaster to check the type of crack in the masonry. In this way, a first diagnosis of the type of damage to the structure was obtained. With this, the type of material with which the masonry is made can be verified, which allowed the type of reinforcement to be applied to the structure to be defined (Figure 10).

Image of coves that are made on the painting, the presence of mural painting is not seen

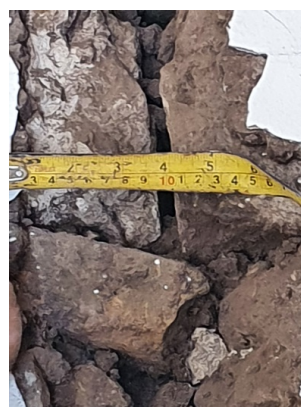
Figure 11

After verifying the type of crack present in the masonry on the exterior side and the width of the opening, it is confirmed that this crack cuts the wall across its entire width. This determines the type of reinforcement to be performed on that crack. Then, the depth of the crack is measured. On the other hand, it is important to verify the length of the crack, for this purpose the plaster is removed⁸, following the direction of the crack (Figure 11).

Image of mud plaster removal detecting the type of crack affecting the masonry

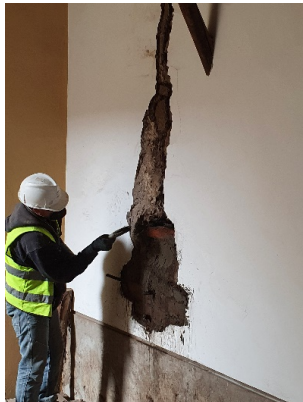
Figure 12

Image of sewn and unsewn crack exterior side

Uncoring and stitching of the wall: the adobe bricks that were broken were removed and replaced with a new element, in this case with mambron brick, which is a material compatible with the adobe and the lime and sand mortar. It is essential that this process be started from the lower part of the wall, in sections of 4 or 5 courses per day, in order to prevent the masonry from settling and producing new cracks. The new bricks are placed one horizontally and the next transversally, so that the new elements are better anchored to the original wall (Figure 12).

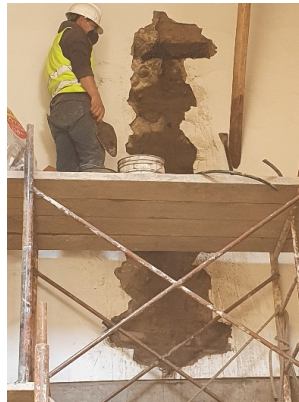
Figure 13

Image of the crack stitching process

This procedure is repeated along the entire length of the crack, one section per day, so that the new intervention is consolidated and does not cause settling and new cracks, the mortars used were prepared with traditional materials with the same characteristics as the original joint mortars (mud, lime and mucilage⁹), this process is repeated until the entire crack is intervened, this intervention procedure is performed on the internal and external side of the wall (Fig.13).

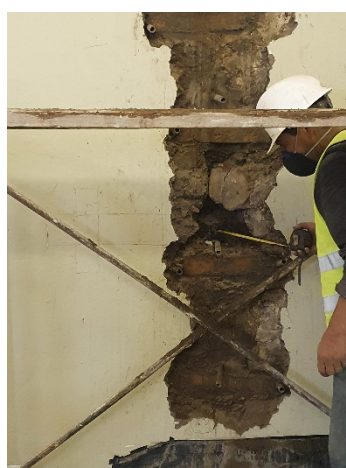
Figure 14

Image of the process of unpicking and stitching of the affected masonry

In addition, it should be noted that, during the stitching and sewing process, ½ inch plastic hoses were placed every 20 to 30 cm of separation, which were connected to internal wall cracks (known as kidney). This is to fully consolidate the structure with grout injections into the internal cracking. The hoses must be laid out over the entire area to be treated, and then lime-based mortars must be injected.

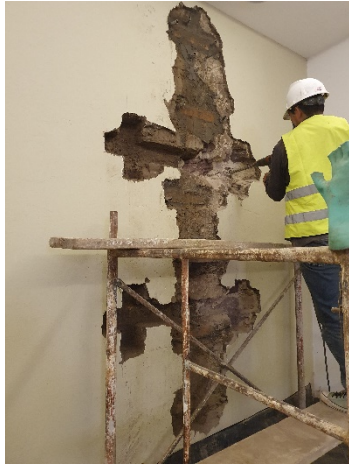
Figure 16

Image of wall perforation for anchoring of wooden keys

The anchorage of these keys was made with 12mm steel rod. These steel bars are placed along the entire thickness of the wall and are anchored at each end of the battens with flat washers and lock washers secured with nuts on each side (Fig.16 and 17).

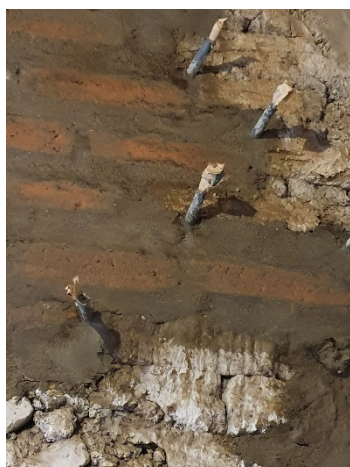
Figure 18

Image of masonry moistened with mucilage to receive the mortar

For monumental buildings, in this intervention the *plastering of traditional materials* was used; its components were: slaked lime, mud, straw, mucilage¹⁵ and water (Barbero, 2011). The thickness of the plaster varies from 1 to 3 cm. To apply this mortar, the surface must first be moistened with mucilage (it can also be moistened with calcium hydroxide) (Fig. 18), so that this process will help the new mortar to adhere better and even seal the possible micro cracks that may occur due to the drying process of the masonry (Fig. 19).

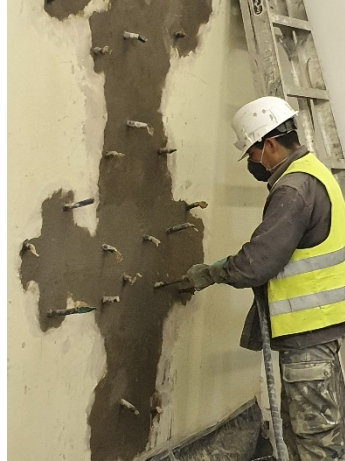
Figure 20

Image of the mortar injection process using an injection gun

As a next step, once the plastering has been completed, the injection process continues in the masonry, to consolidate the interior of the walls by *injecting hydraulic lime mortar*. This is due to the fact that the masonry is made of adobe and brick. This mortar for the injections was prepared with the following materials and proportions: hydrated lime 3, red or brown pozzolana 1, washed river sand 2, water 3, stabilizing additive 2% of the weight of the pozzolana (Instituto Metropolitano de Patrimonio [IMP], technical specifications for execution of works, 2021).

The filling process starts with the lower hoses and as they are filled, the process continues to the upper hoses. Once they are filled, they are temporarily covered with paper to prevent the injection fluid from leaking out; the next day the injection process is
